MARINE INVESTIGATION REPORT
M00W0303

STRIKING OF A BRIDGE

TUGBOAT *MILLER RICHMOND* AND
BARGES *MILLER 201* AND *MILLER 206*
PITT RIVER HIGHWAY BRIDGE, BRITISH COLUMBIA
18 DECEMBER 2000

Report Number M00W0303

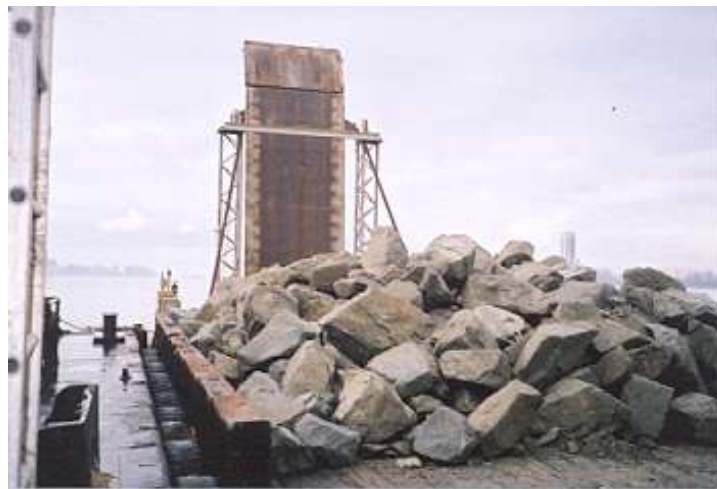
Photo 2. The barge *Miller 201* with ramp

The *Miller 201* suffered extensive damage to the shell on the starboard forward corner in way of the collision bulkhead.

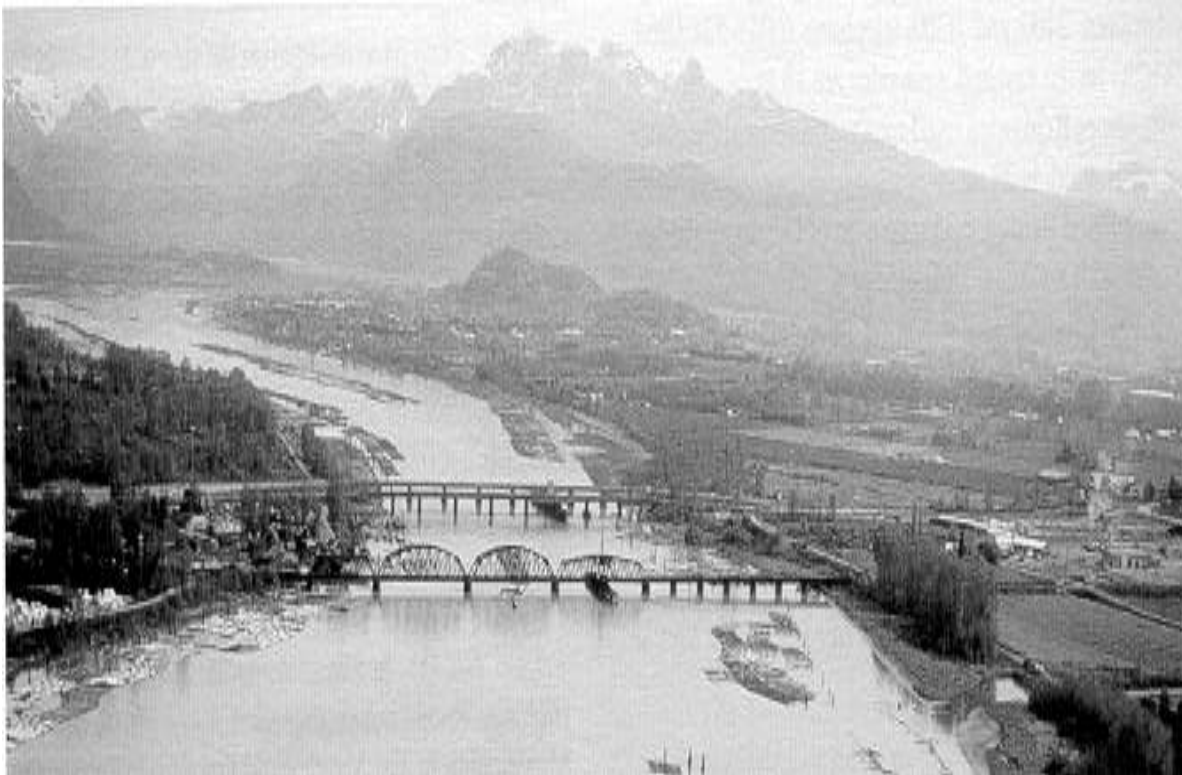
Photo 1. River Bridges looking upstream (1999)
